# Roof Inspection Report

Property Address Street: [REDACTED]  
City: Summit  
State: NJ  
Zip: 07901

Date of Inspection: 2/24/20

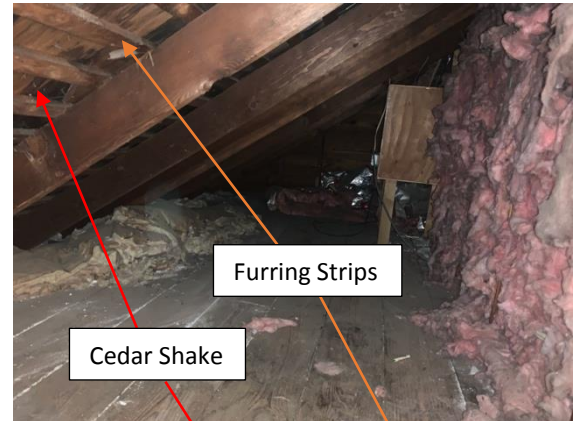
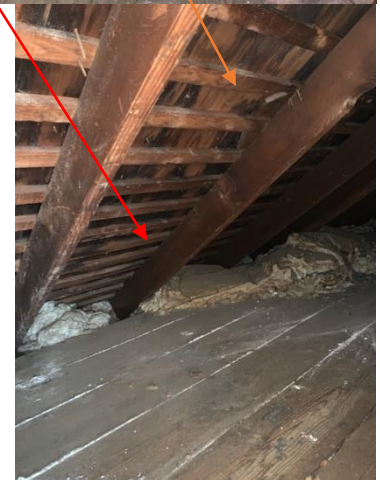
The accessible knee-wall on the 3<sup>rd</sup> story of the house clearly shows the decking for what is likely the original structure. The only sheathing is a layer of cedar shake nailed directly to furring strips. The cedar shake was damp to-touch throughout the area. Of the 19 Square on the main dwelling, about 11 Square is made up of this type of decking.

The soffit areas in the knee wall attic are also clogged with fiberglass insulation (see photos in Decking section) which would cut off the intake of fresh air, even if the soffits were open and vented from outside. During the roof's replacement, the soffit can be ventilated, the fiberglass blocking the intake can be cleared, and a baffle system can be installed to allow the fresh air to pass from the soffit to the ridge. Using that method, the attic fan can be removed to avoid the maintenance and remove the negative curb appeal of the fan being visible from the street (see photo in Algae and Moss section). If there is an obstruction that blocks the installation of a baffle system, the fan can remain and will work properly along with the open soffits.

A new roof can't be installed over furring strips, so after the layers of roof and cedar shake are removed 5/8" CDX Roof Sheathing should be installed to support new roof system for the 11 square of cedar shake.

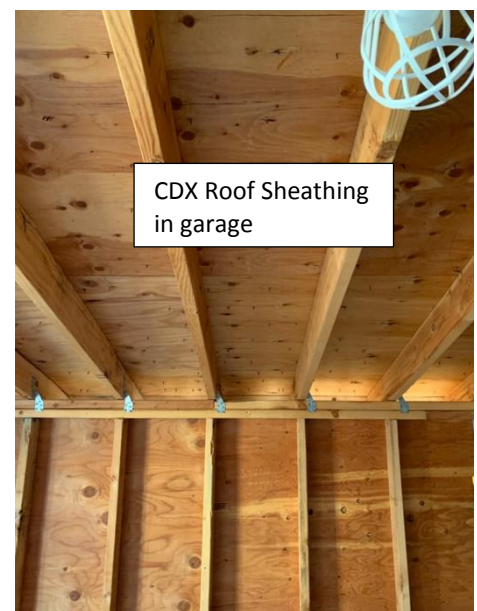
The detached garage has proper roof sheathing. The sheathing can be observed inside the garage and appears to be in like-new condition.

There are open soffits in the garage (see photo in Decking Section) which allow fresh air to pass into the garage, but a ridge vent should be installed to avoid moisture issues that could deteriorate the plywood during humid months. Ridge is currently closed but is easily cut back during roof replacement.

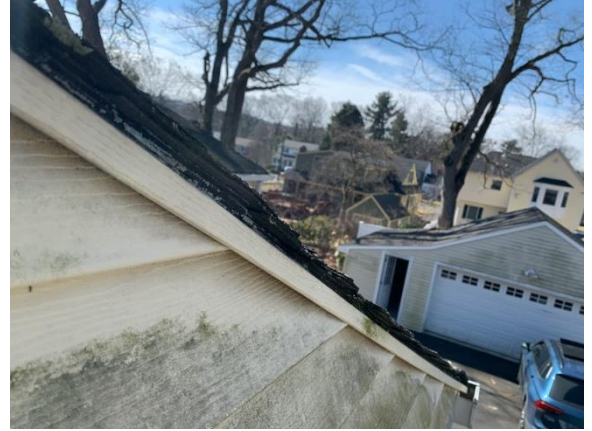
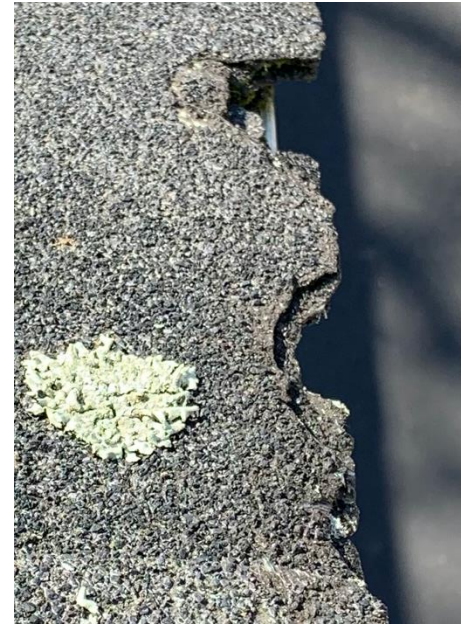
There are several areas on the main roof where the edges of the shingle are exposed. There is no evidence of ice/water shield barrier on any parts of the roof. This contributes to the granule loss by making it nearly impossible for the old shingle to completely dry.

The layers of roof shingle installed over top of the cedar shake don't seem to have any underlayment. Many areas are dry rot and broken, revealing the lack of underlayment.

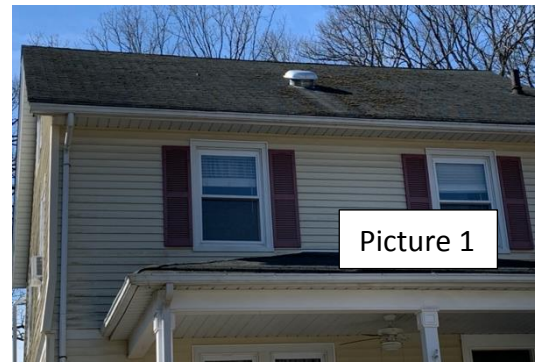
The attic fan is made of a zinc infused galvanized material which kills algae as it grows. There is a streak underneath the fan where the rain runs off of the roof and it is clear from the street that the rest of the roof is completely covered with black algae (picture 1).

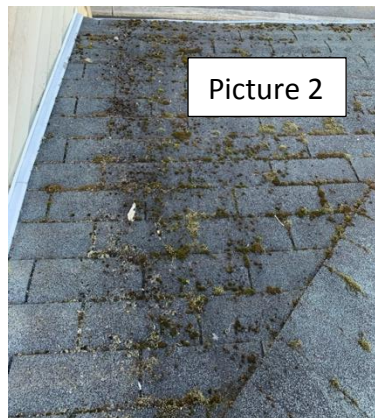
The front porch roof is covered in both algae and moss (picture 2)

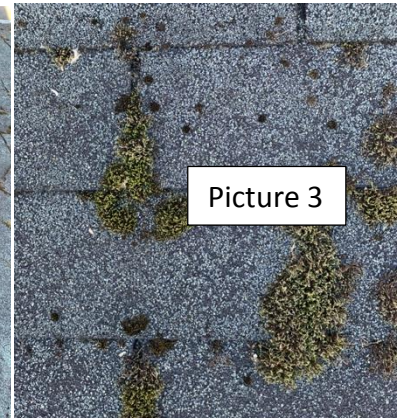
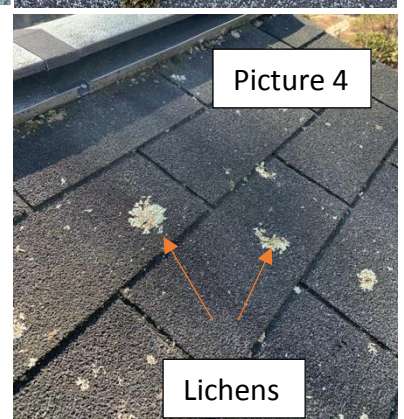
Lichens (a severe algae growth organism) are growing on many areas of the rear roof on both the original structure and on the addition (picture 4). Lichens grow mostly in areas where granules have fallen off the roof shingle. Lichens can sometimes be killed but can't be removed without

damaging the shingle. The lichen growth may be related to the ventilation of these areas. The rear addition roof should be replaced, and the presence of proper ventilation should be confirmed to avoid damage to the roof sheathing that is likely still in good condition.

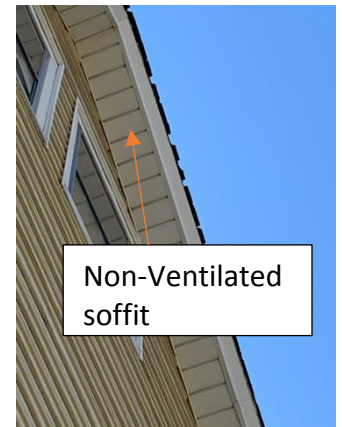
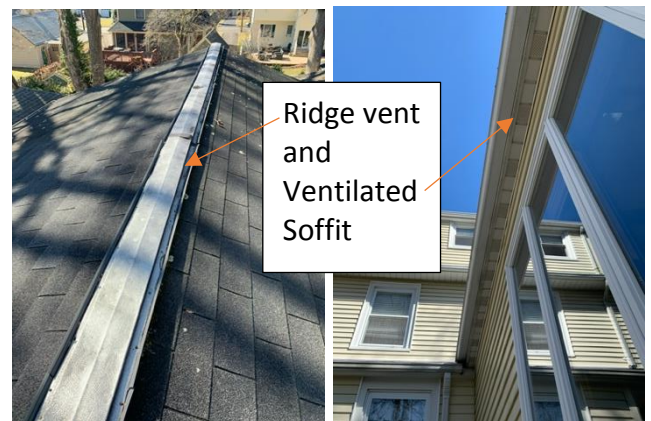
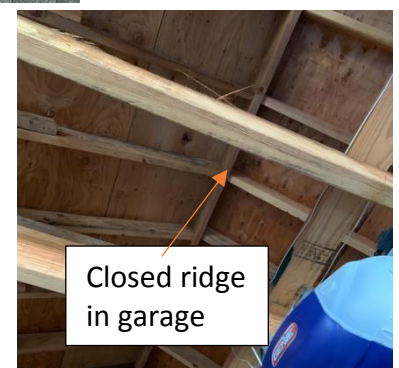
On the original structure, there is no ventilated soffit or any other forms of fresh air intake. There is an attic exhaust fan located in the knee-wall attic, but without any open areas for fresh air intake there is no fresh air coming from outside to replace the air passing through the exhaust. When the fan turns on, it will pull air from the living space of the 3<sup>rd</sup> floor which causes waste and inefficiencies in heating and cooling the house.

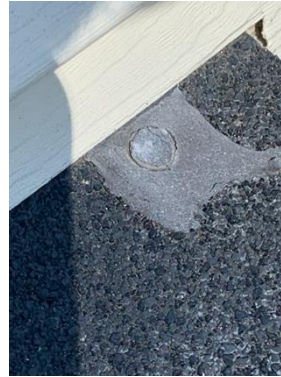
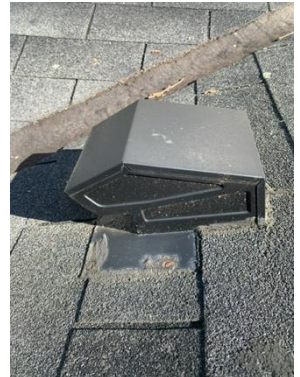
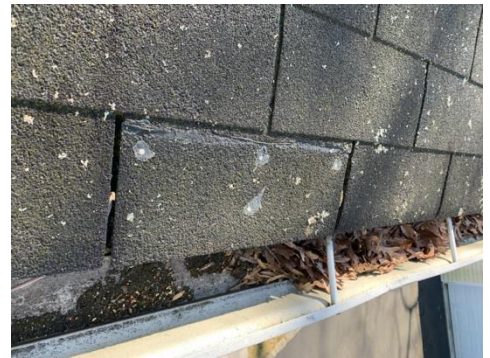
There are several areas where the existing shingle was face nailed and poorly sealed. Face nailing shingle is almost never necessary, but in cases where it is needed, the sealing of the nail is extremely important. The nails will leak, rust, and pop, leaving the roof system vulnerable to leaks and blow-offs.

The rear addition bathroom vent was installed over top of the shingle which caused a leak around the fan (see photo in Interior of House section). All pipe boots around house need to be removed and replaced during the roof replacement.

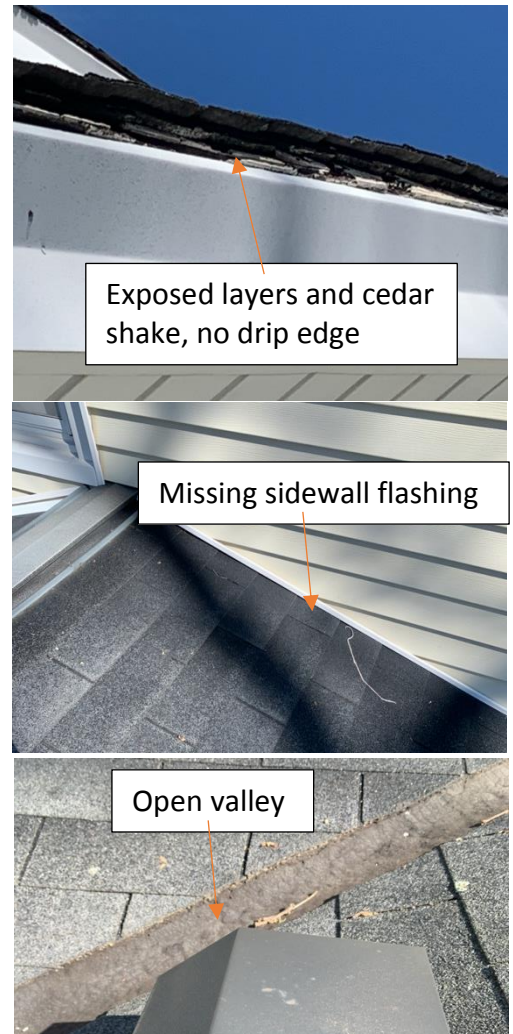
There is no drip edge on the roof. The entire roof is exposed to water on the edges.

The flashing is incomplete in several areas and non-existent in others. The siding needs to be removed in sidewall areas so that proper step flashing and ice/water barrier can be installed. The siding would then be re-installed.

The valleys are open and there is no metal to protect the decking. Currently, there is just thick layers of tar.

When the roof is replaced, the valley would be protected by ice/water shield and shingle. All of the existing flashing on the house should be removed and replaced to assure proper installation.

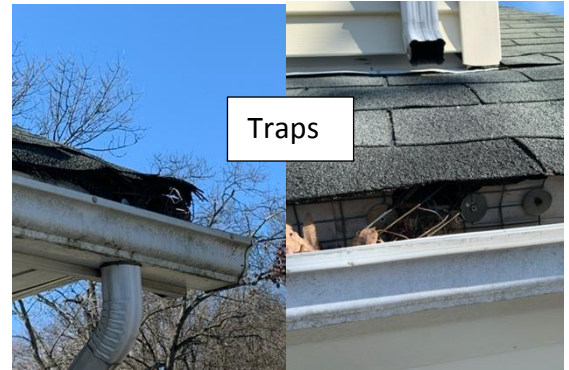
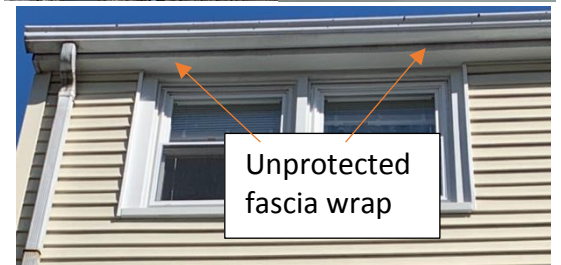
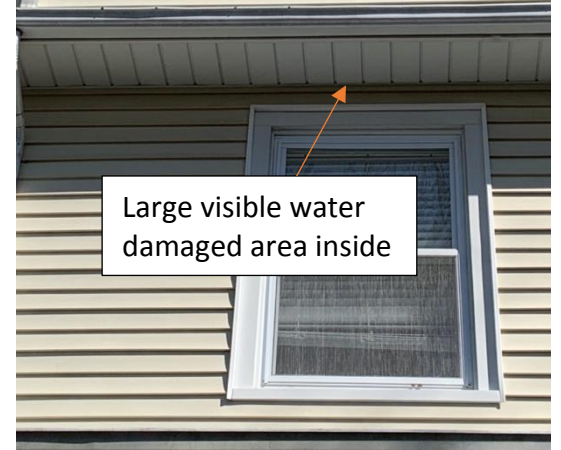
The fascia and aluminum wraps on the house are falling off or missing in several areas. There are also two areas where homemade traps, likely to remove birds or mice, were drilled into the fascia along the gutter line.

The main area of concern is on the back side of the house. The aluminum was wrapped around the soffit and eave, behind the gutter, and is not protected by drip edge. The gutters are clogged and in disrepair, so the water is backing up and getting behind the aluminum. This is likely the cause of the large leak over the back window on the second floor.

The soffit on the original structure is aluminum and is non-ventilated. The soffit should either be replaced with a vented soffit during the roof installation or holes should be drilled to add soffit vents.

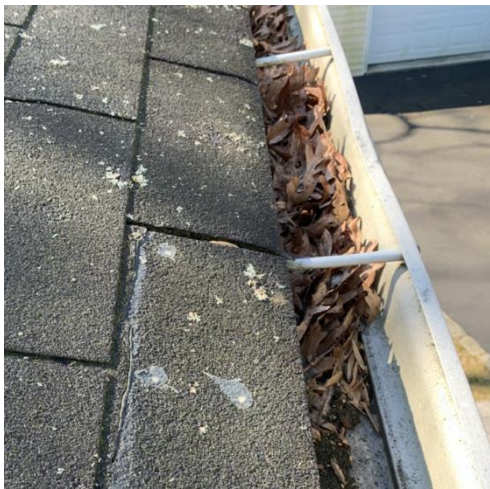
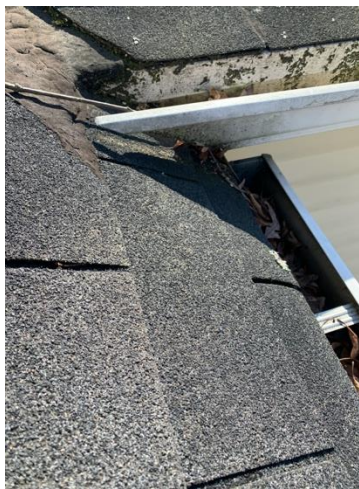
Gutters are clogged and in complete disrepair. End caps are missing, the nails are popping, areas have been cut to make room for rodent traps, downspouts are loose, and the entire system is dented up from debris. Immediate replacement needed. Recommend a covered gutter system, such as ShurFlo, to avoid clogging.

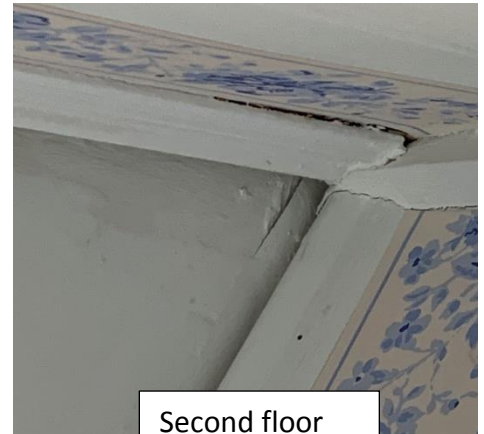
There are a couple areas of visible water damage, the most concerning being the second-floor leak as referenced in the Fascia section.

Second floor  
bedroom leaks

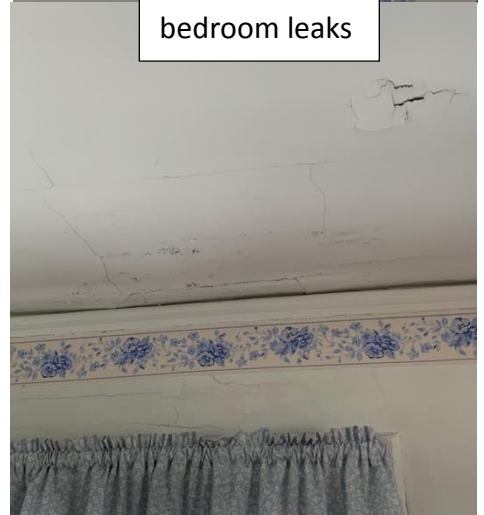
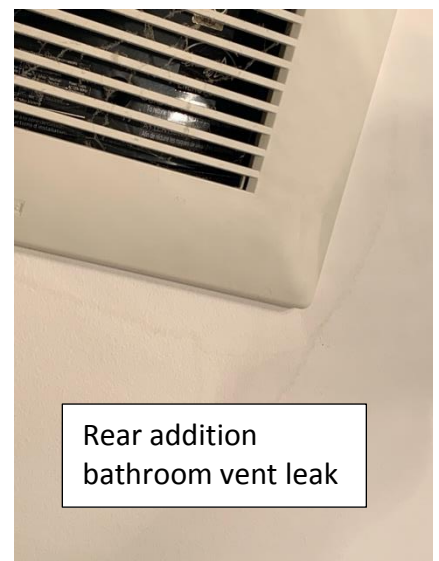
The bathroom in the rear addition also has a leak coming in through the bathroom vent.

Rear addition  
bathroom vent leak
