# Roof Inspection Report

Property Address Street: [REDACTED]  
City: Summit  
State: NJ  
Zip: 07901

Date of Inspection: 2/24/20

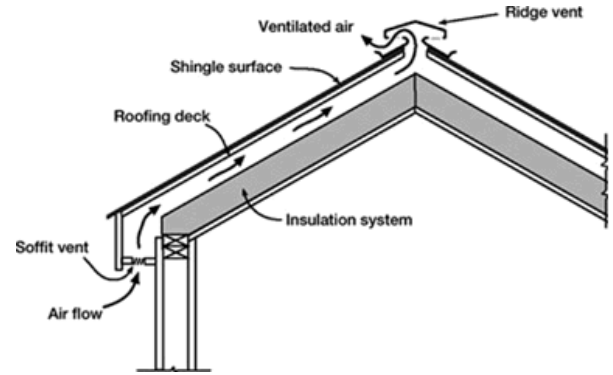
On the original structure, there is no ventilated soffit or any other forms of fresh air intake. There is an attic exhaust fan located in the knee-wall attic, but without any open areas for fresh air intake there is no fresh air coming from outside to replace the air passing through the exhaust. When the fan turns on, it will pull air from the living space of the 3<sup>rd</sup> floor which causes waste and inefficiencies in heating and cooling the house.

The soffit areas in the knee wall attic are also clogged with fiberglass insulation (see photos in Decking section) which would cut off the intake of fresh air, even if the soffits were open and vented from outside. During the roof's replacement, the soffit can be ventilated, the fiberglass blocking the intake can be cleared, and a baffle system can be installed to allow the fresh air to pass from the soffit to the ridge. Using that method, the attic fan can be removed to avoid the maintenance and remove the negative curb appeal of the fan being visible from the street (see photo in Algae and Moss section). If there is an obstruction that blocks the installation of a baffle system, the fan can remain and will work properly along with the open soffits.
